NASA TM-81660

Test Results of the Chrysler Upgraded Automotive Gas Turbine Engine—Initial Design

July 1981

Prepared for
U.S. DEPARTMENT OF ENERGY
Conservation and Renewable Energy
Office of Vehicle and Engine R&D

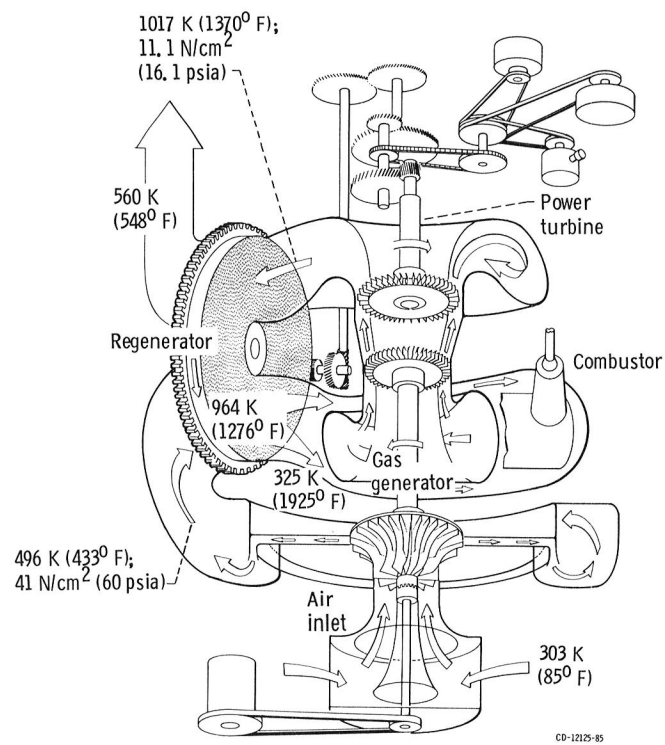
Figure 1. - Schematic of Chrysler upgraded engine.

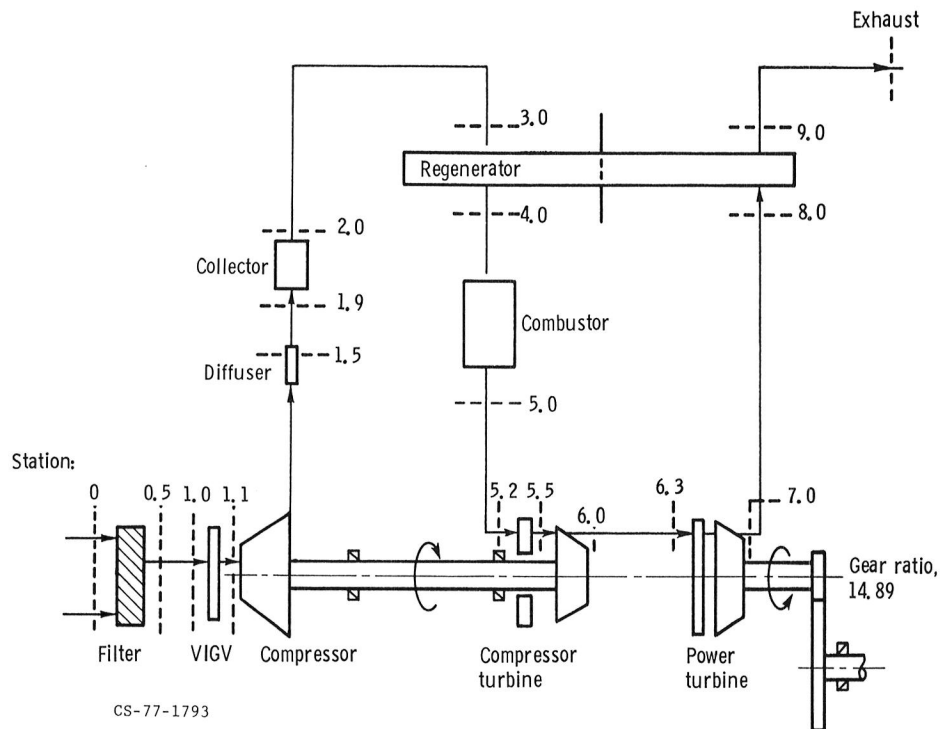
Figure 3. - Station positions.

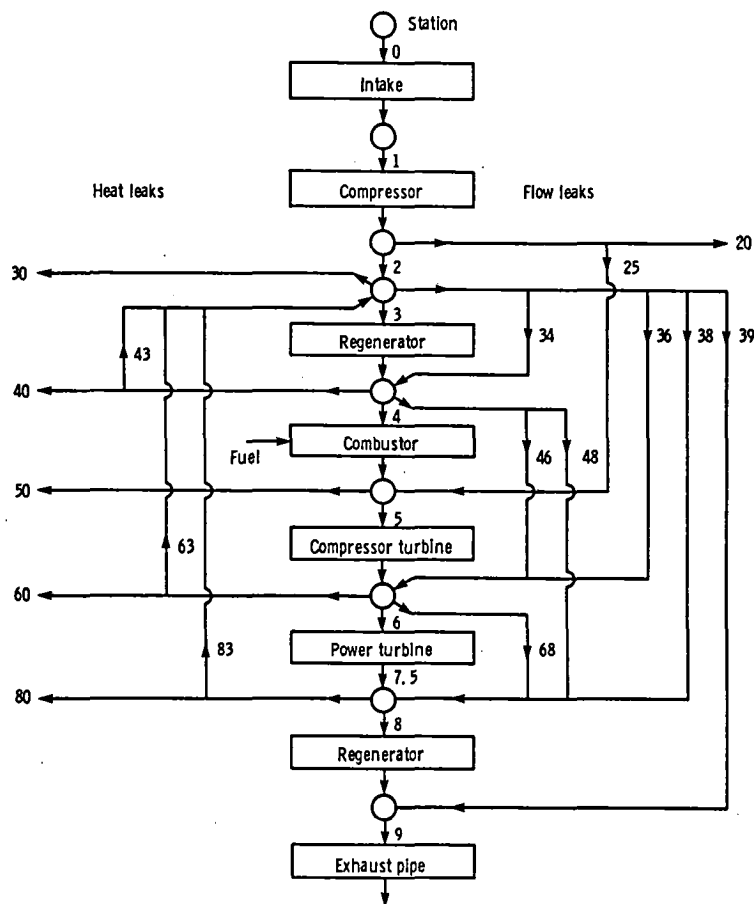
Figure 7. - Characterization schematic of Chrysler upgraded engine.

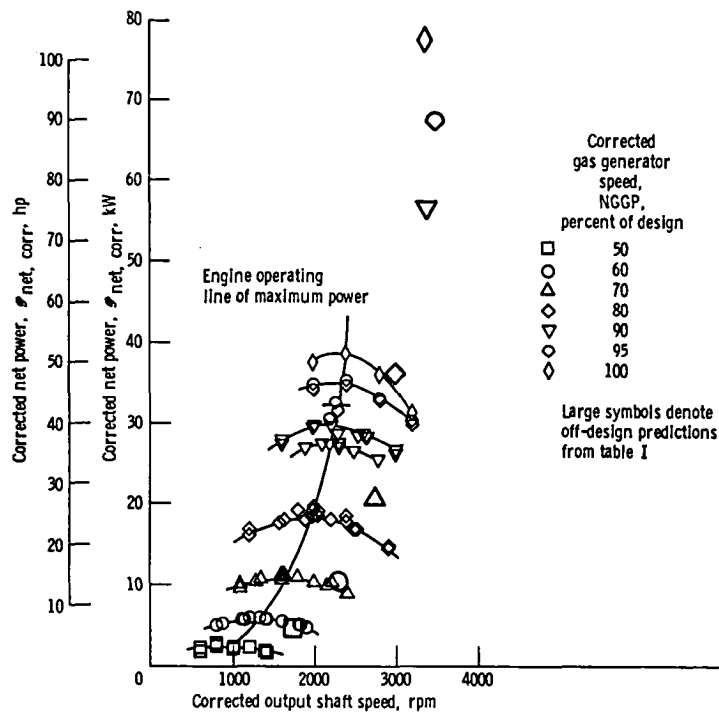
Figure 8. - Engine map - corrected power as a function of corrected speed. Design speed, 58 500 rpm.

An engine performance map showing the relationship between power, output shaft speed, and gas generator speed is presented in figure 8. The map clearly shows the deficiency in power and output shaft speed. There is noticeable scatter among the 90 and 95 percent gas generator speed points in figure 8. For a given gas generator speed the higher values of power were obtained while the engine was being tested for exhaust emissions. It was found that the reason for this scatter is that the engine performance was very sensitive to small variations in actual T_g . When the engine was performance tested, a 14-thermocouple average was used to control T_g ; but when the emissions data were taken, only four thermocouples were used. The result was a difference of about 10 K. Reference 5 presents a sensitivity analysis of various operating parameters on this engine and shows that a 10 K increase in T_g causes a 2.5-kilowatt increase in engine power.

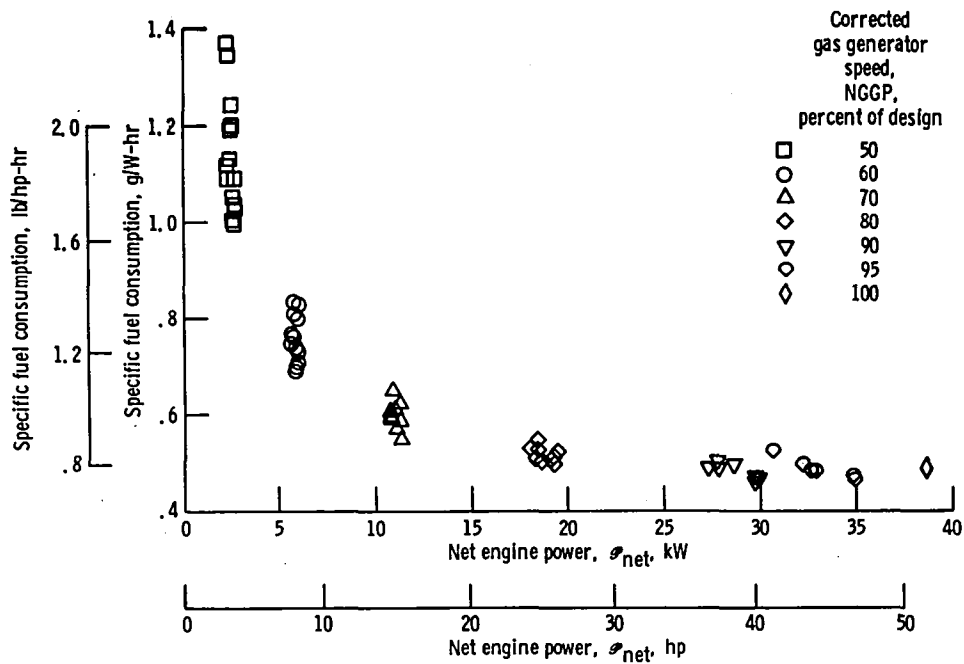
Figure 9. - Engine operating line - specific fuel consumption as a function of characteristic power. Design speed, 58 500 rpm.

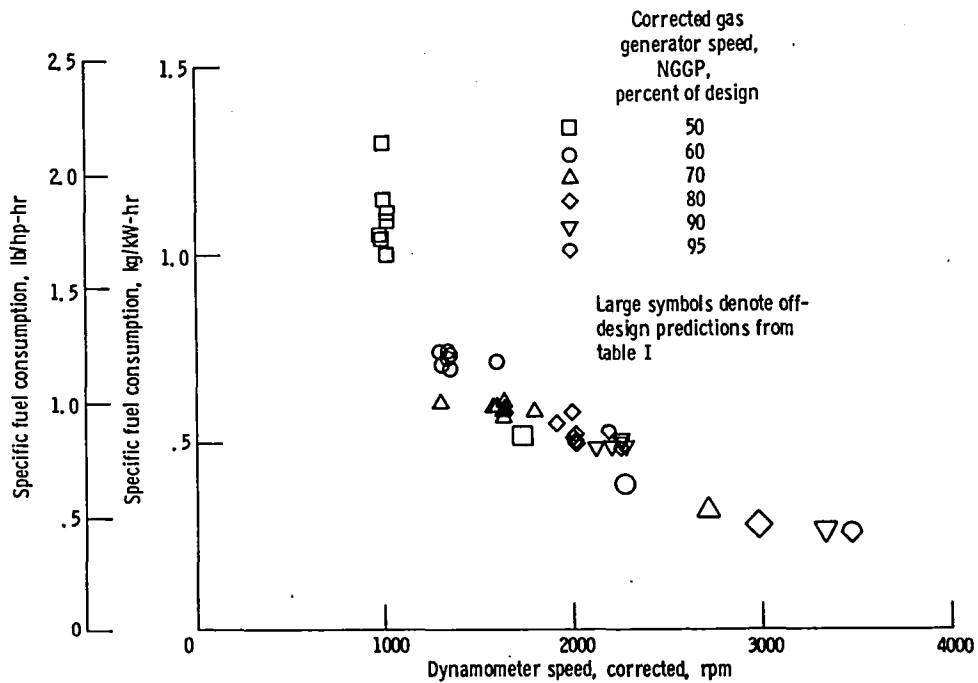
Figure 10. - Engine operating line - specific fuel consumption as a function of dynamometer speed.

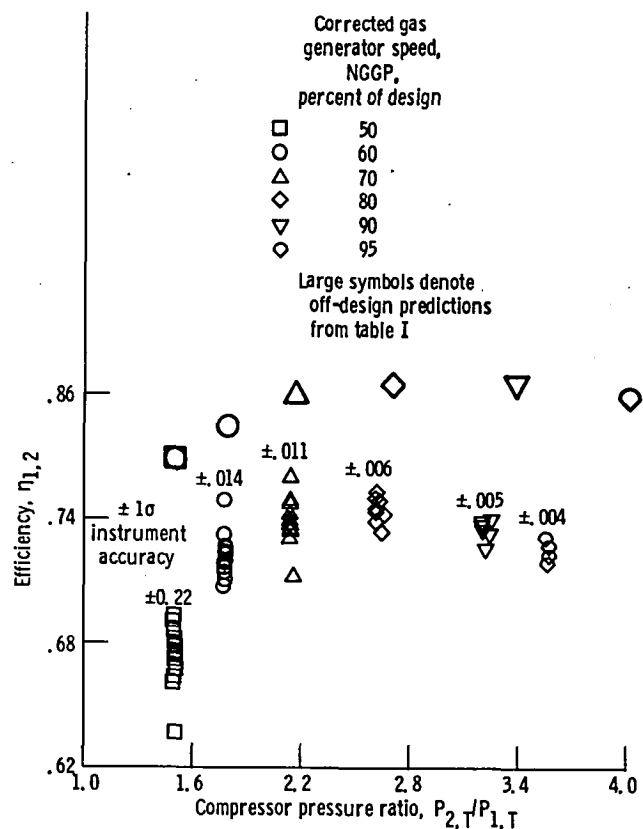
Figure 13. - Compressor efficiency as a function of pressure ratio -

engine tests. Efficiency = $T_1 \left[\left(\frac{P_2}{P_1} \right)^{(\gamma-1)/\gamma} - 1 \right] / T_2 - T_1$

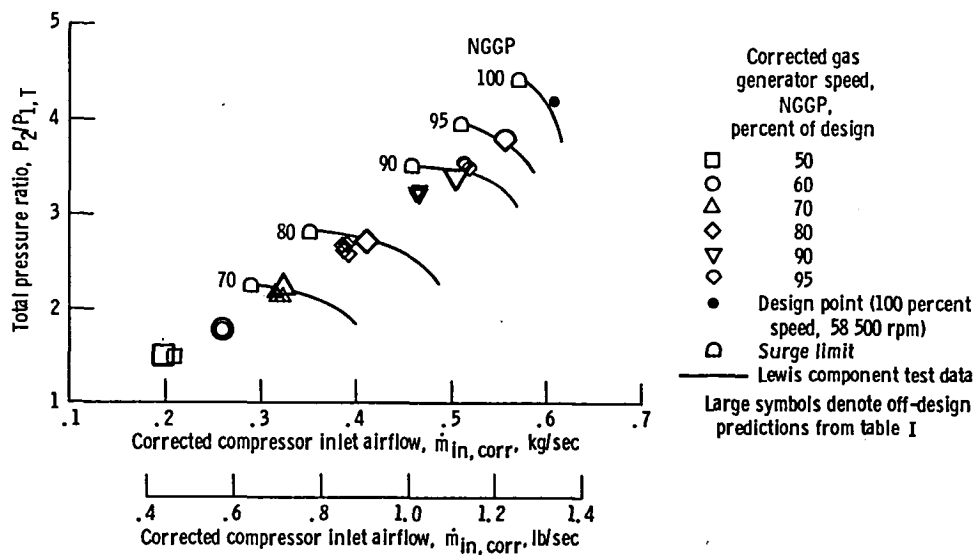
Figure 14. - Compressor pressure ratio and mass flow characteristic - component tests. (Component data were interpolated from data in ref. 12 and corrected for a scale factor of 1,259 reference inlet temperature.)

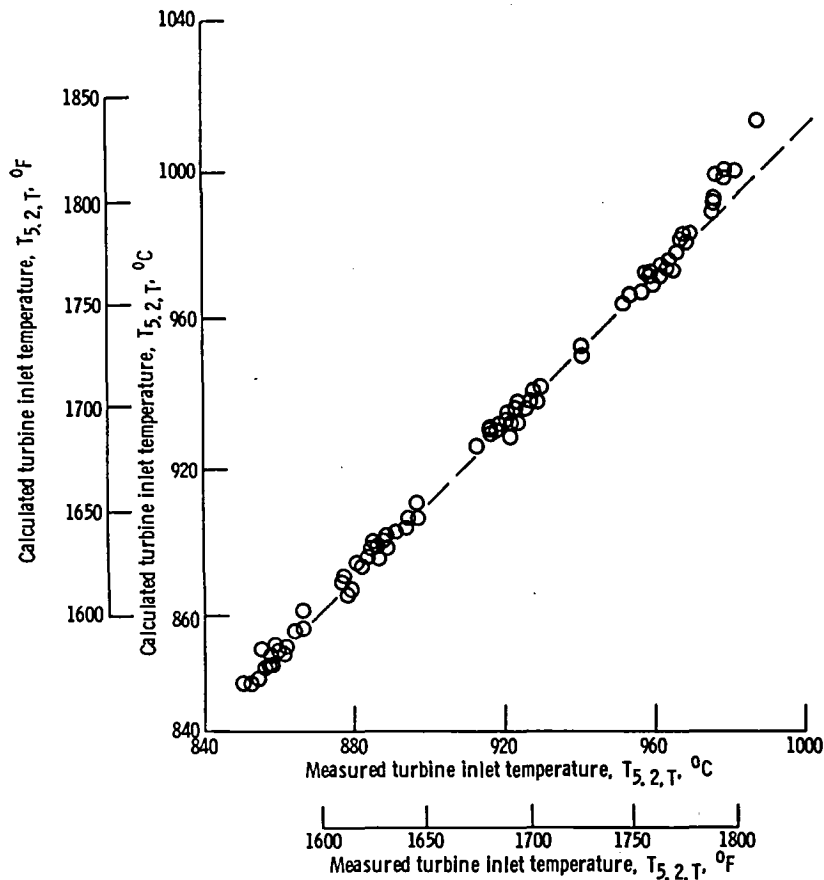
Figure 16. - Comparison of measured and calculated turbine inlet temperature.

$$T_{5,2, \text{calc}} = T_{6,T} + \frac{(h_{1,5} - h_{1,1}) \left(\frac{\dot{m}_{in}}{\dot{m}_{in} + \dot{m}_f - \dot{m}_{leak}} \right) + \Delta h_{par}}{C_p}$$

where C_p is the specific heat for the temperature $(T_{5.2,T} + T_{6,T})/2$. Then $T_{5.2,calc}$ was compared with the measured compressor turbine inlet temperatures in figure 16. This plot shows that the calculated and measured temperatures tended to agree, except for the high-temperature points that were taken at very near full throttle. This agreement lends some evidence that at low speeds the three-temperature average is a close approximation to the mean fluid temperature and that the leakage and parasitic loss estimations made by Chrysler (refs. 1 and 2) are reasonable.

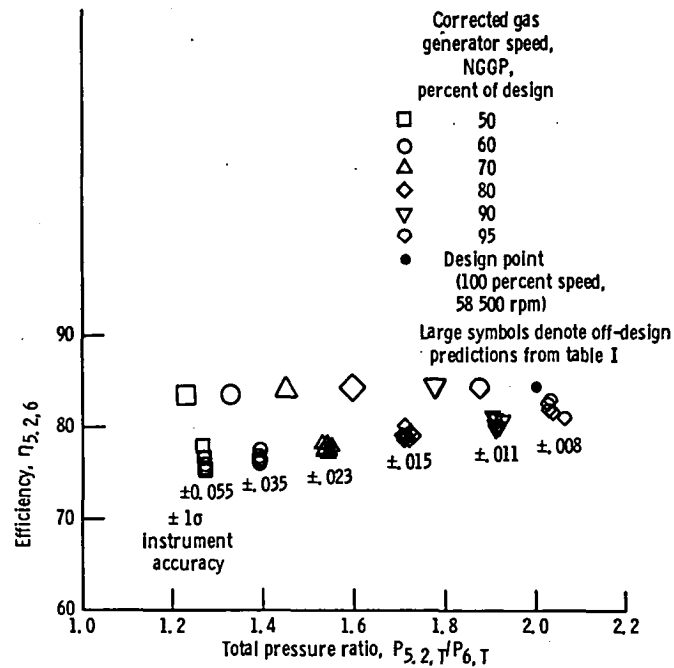
Figure 17. - Compressor turbine efficiency (based on compressor work and predicted parasitic losses and leakage).

$$\eta_{ct} = \frac{\dot{W}_{comp} + \dot{W}_{par, des}}{\Delta h_{id}(\dot{m}_{in} + \dot{m}_f - \dot{m}_{leak})}$$

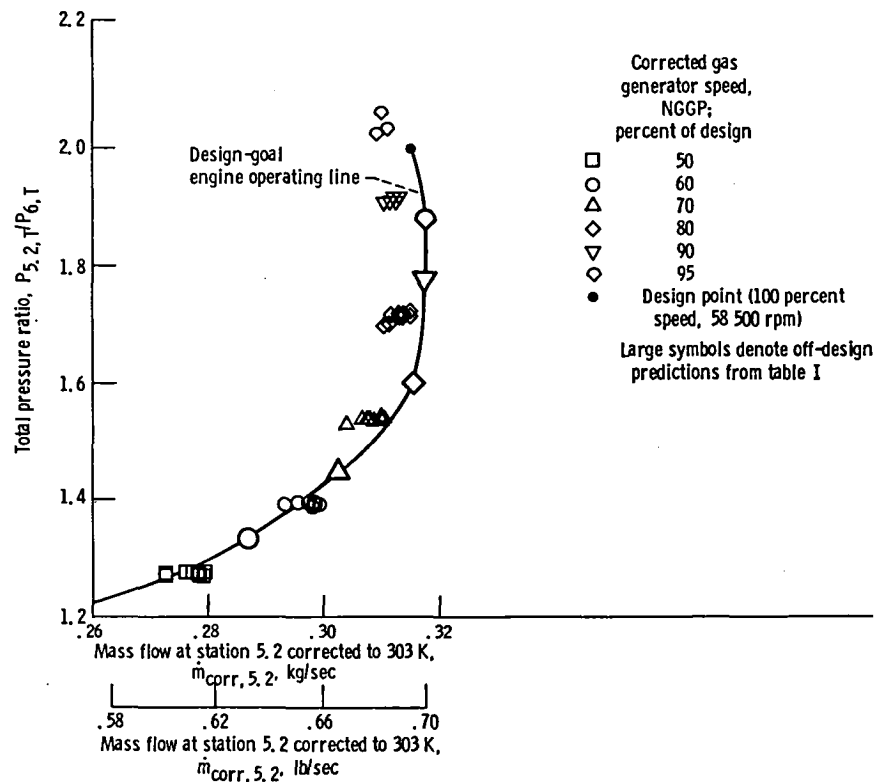
Figure 18. - Compressor turbine pressure ratio and mass flow characteristic.

$$\dot{m}_{corr} = \frac{(\dot{m}_{in} + \dot{m}_f - \dot{m}_{leak}) \sqrt{\frac{T_{5,2,T}}{303 K}}}{\frac{P_{5,2,T}}{101 \text{ kPa}}}$$

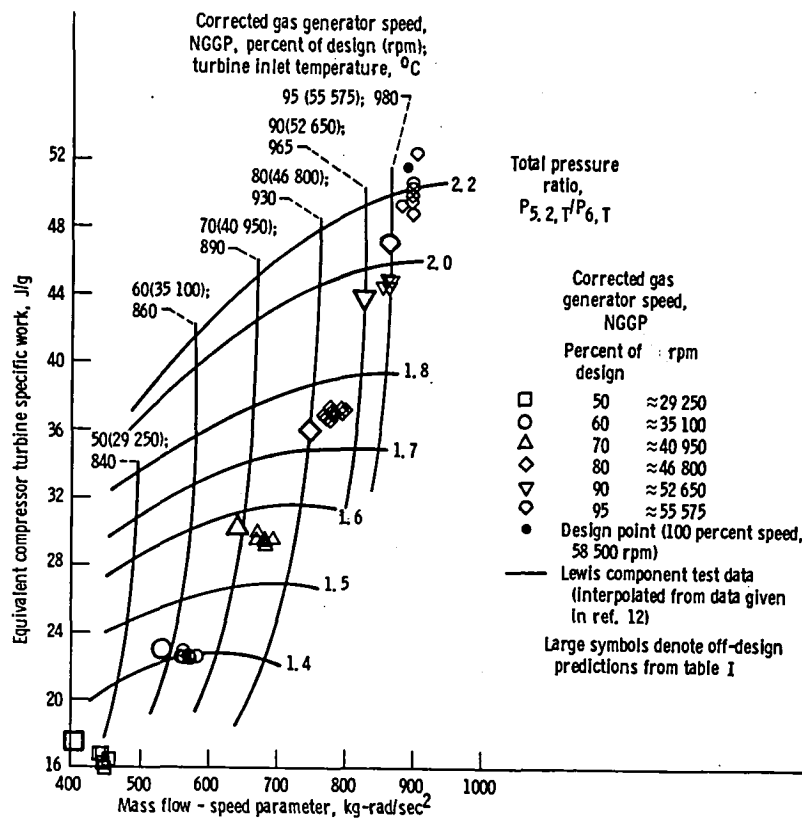
Figure 19. - Compressor turbine map - component tests.

$$\text{Mass flow - speed parameter} = \frac{(585, 0) \text{ NGGP } (\dot{m}_{in} + \dot{m}_f - \dot{m}_{leak}) \frac{2\pi}{60}}{\frac{P_{5,2,T}}{101.3 \text{ kPa}}}$$

$$\text{Equivalent compressor turbine specific work} = \frac{(h_{1,5} - h_{1,1}) \dot{m}_{in} + \dot{q}_{par}}{(\dot{m}_{in} + \dot{m}_f - \dot{m}_{leak}) \theta_{cr}}$$

Lewis engine data plotted on the compressor turbine component map are shown in figure 19. All the lines in the plot were derived from compressor turbine component test information that is yet unpublished. The equivalent specific work shown in the plot is corrected to 302.6 K. Figure 19 shows that for any speed, turbine inlet temperature, and specific work, the mass flow - speed parameter from the engine test is 5 percent higher than the component test data indicate. It is expected that thermal expansion of the engine caused at least 2 percent greater equivalent flow than experienced during the compressor turbine component tests, which were run near ambient temperature. The cause of the remainder of the disagreement is not known. The large symbols in figure 19 represent the off-design predictions and were calculated from the temperatures, pressures, speeds, flows, and heat leaks given in table I.

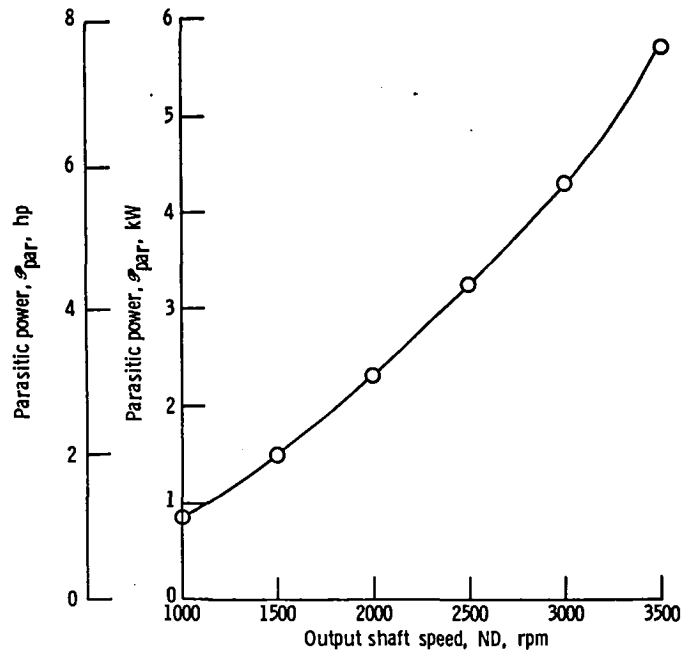
Figure 21. - Power turbine shaft parasitic losses. Dummy power turbine shaft; gas generator and regenerator installed; oil inlet temperature, 66°C ; gas generator speed, NGG, 80 percent of design; low-pressure-side regenerator inlet temperature, T_8 , 749°C .

where $\dot{\mathcal{P}}_{net}$ is the power measured at dynamometer, $\dot{\mathcal{P}}$ is the parasitic losses shown in figure 21, \dot{m}_{leak} is the predicted leakage based on figure 7 and table I, and C_p and γ are the specific heat and ratio of specific heats for air with water vapor and combustion products at the average temperature through the stage.

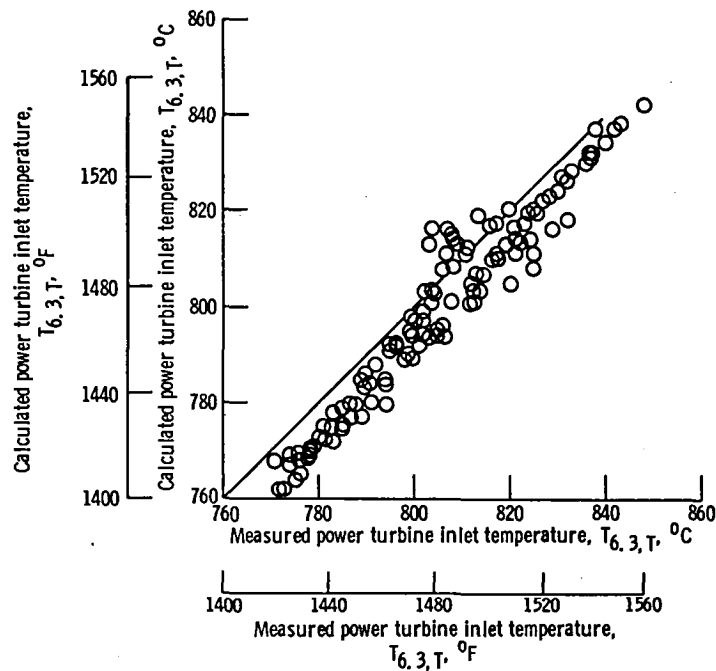
Figure 22. - Comparison of measured and calculated power turbine inlet temperature.

$$T_{6, 3, T, \text{calc}} = T_{7, T} + \frac{\mathcal{P}_{\text{net}} + \mathcal{P}_{\text{par}}}{(\dot{m}_{\text{in}} + \dot{m}_f - \dot{m}_{\text{leak}}) C_p}$$

A comparison similar to that used on the compressor turbine was made to determine if there was a general agreement between the power turbine work measured with the dynamometer and the work calculated from the temperature measurements and flow rate. Figure 22 shows the comparison. In almost every case the measured temperature was significantly higher than the calculated temperature, and the difference was fairly consistent. This difference might be due to heat losses and leakage flow from cooler and higher pressure parts of the engine coming in through the variable stator mechanism. The points above the line, where the calculated power turbine inlet temperature is greater than the measured, represent engine operating conditions above 95 percent of design gas generator speed. Considering that temperature drop across the power turbine stage is as small as 24 K at idle, there can be little confidence in using measured temperature difference to calculate the power turbine efficiency.

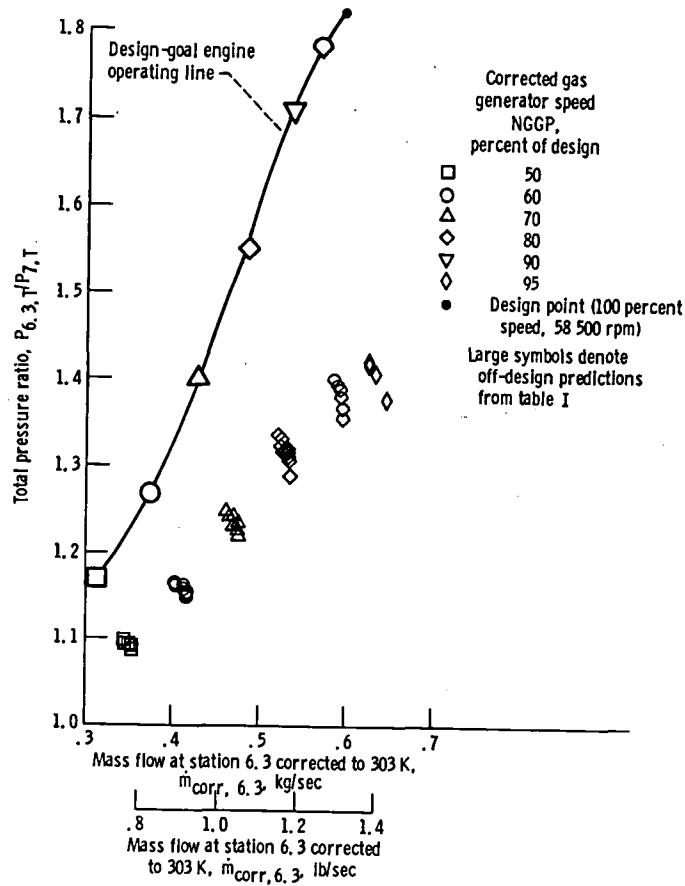
Figure 23. - Power turbine pressure ratio and mass flow characteristic.

$$\dot{m}_{corr} = \frac{(\dot{m}_{in} + \dot{m}_f - \dot{m}_{leak}) \sqrt{\frac{T_{6.3,T}}{303 K}} \epsilon}{\frac{P_{6.3,T}}{101 \text{ kPa}}}$$

The power turbine performance is summarized in figures 23 and 24. Figure 23 shows the relationship between pressure ratio, mass flow, and gas generator speed. Gas generator speed can be related to actual mass flow by referring back to figure 14. The design-goal engine operating line is also plotted in figure 23 in order to show the disparity between the operating conditions and the predicted conditions. The efficiency is compared with the design prediction in figure 24. Here efficiency based on measured engine output power and turbine pressure ratio is plotted against work factor. The plot shows that efficiency was at least 17 percentage points low at the design work factor of 1.25. The design work factor and efficiency were taken from reference 2.

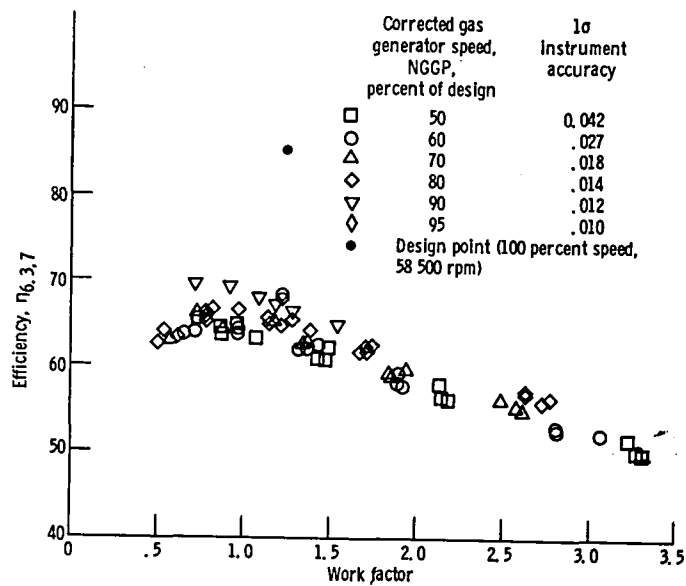
Figure 24. - Power turbine efficiency (based on dynamometer).

$$\text{Efficiency} = \frac{\dot{P}_{net} + \dot{P}_{par}}{(\dot{m}_{in} + \dot{m}_f - \dot{m}_{leak}) \times \Delta h_{ld}}$$

$$\text{Work factor} = \frac{\dot{P}_{net} + \dot{P}_{par}}{(\dot{m}_{in} + \dot{m}_f - \dot{m}_{leak}) \times U^2}$$

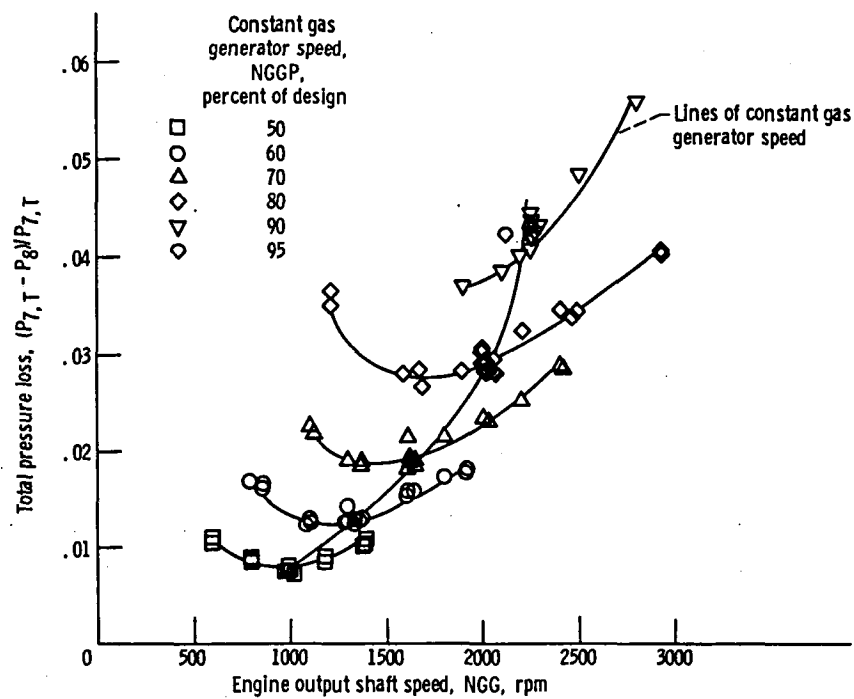
Figure 25. - Power turbine diffuser pressure loss. Design speed, 58 500 rpm.

The total pressure loss in the power turbine diffuser is shown as a function of gas generator speed and output shaft speed in figure 25. The lines of constant gas generator speed also represent constant flow rate in the power turbine diffuser inlet for the range of conditions tested. The minimum pressure loss in each line of constant gas generator speed should represent the speed of the output shaft at which the total velocity of the fluid is at a minimum. Since the flow is axial when the total velocity is at a minimum, the output shaft speeds associated with the minimum in figure 25 are the speeds that will cause axial flow for a given flow rate and gas generator speed. The locus of points that form the engine operating line of maximum power tends to follow the minimums, as would be expected, since a large swirl at the rotor exit would cause a large pressure drop in the diffuser.

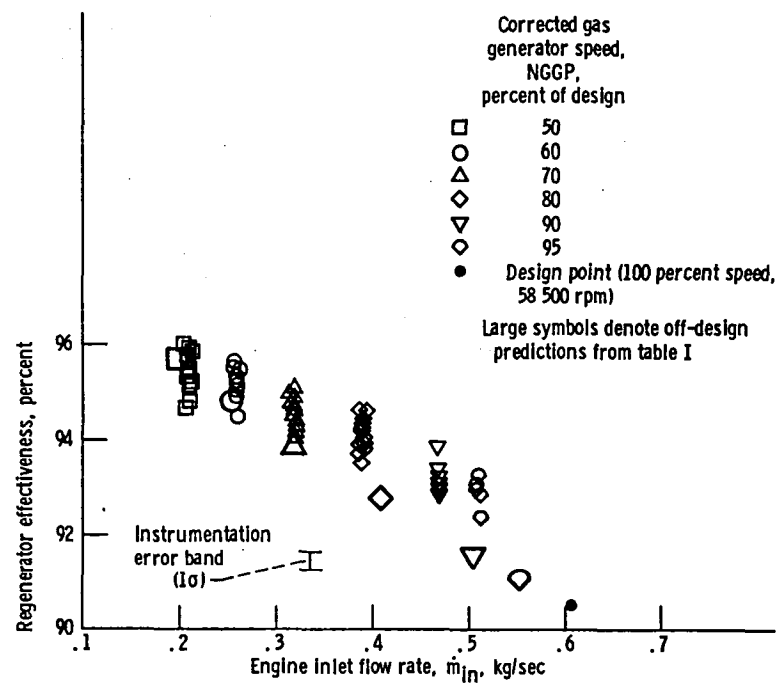
Figure 26. - Regenerator performance. Effectiveness = $\frac{T_4 - T_3}{T_8 - T_3}$

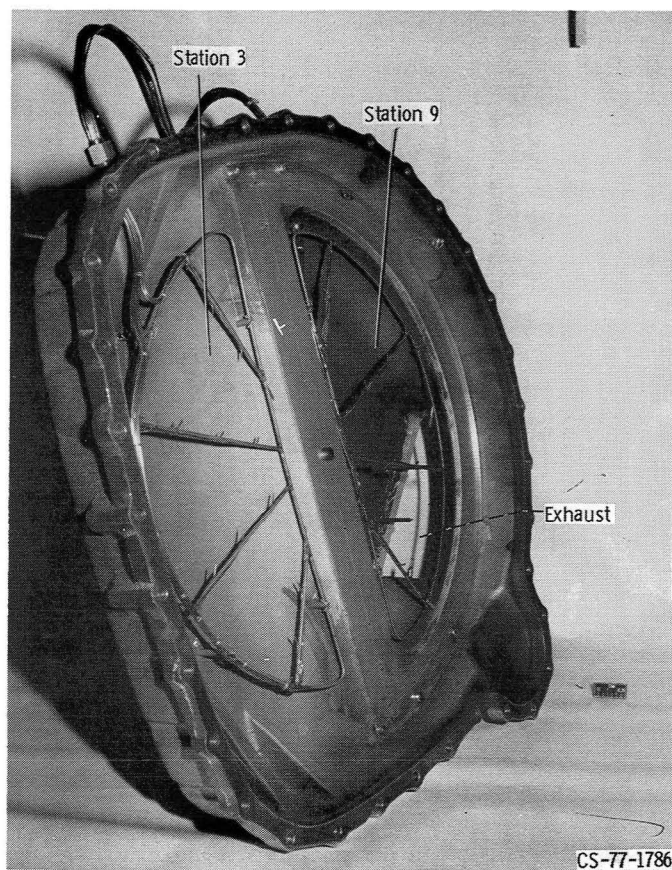
Figure 27. - Regenerator instrumentation - a view of inside of regenerator cover showing thermocouple grid.

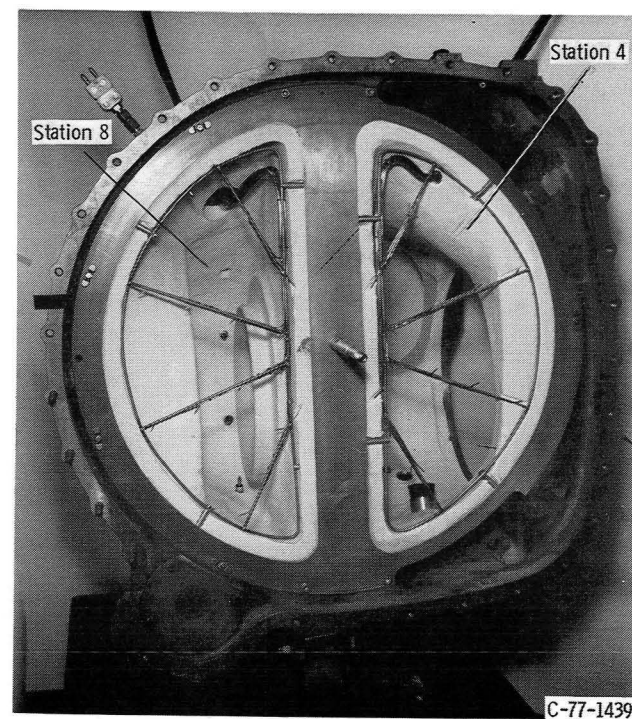
Figure 28. - Regenerator instrumentation - view into engine housing with regenerator disk and turbine shafting removed.

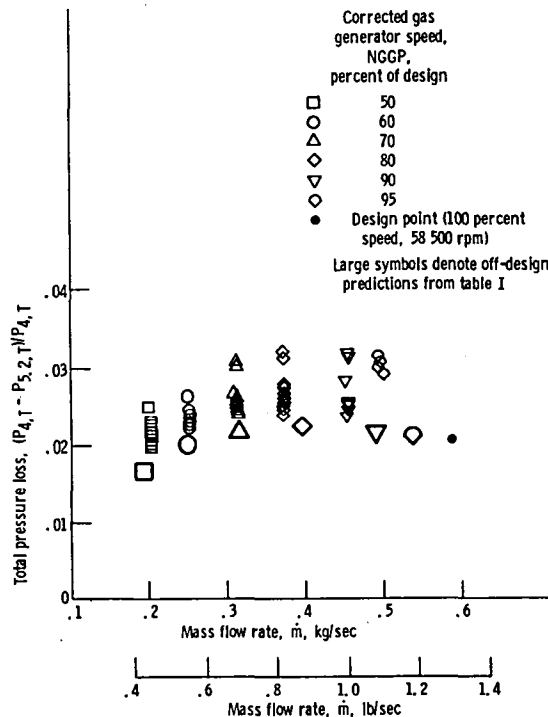
Figure 31. - Combustor-vortex pressure loss (noninstrumented combustor).

Pressure loss in the combustor and vortex is shown in figure 31. The small symbols represent test data, and the large symbols are the off-design predictions made by Chrysler and presented in table I. Figure 31 shows that the actual pressure drop was slightly higher than that predicted for any given flow rate. Some of the scatter in the data of figure 31 was caused by a modification of the dilution holes in the reactor tube made during the test program. As a possible solution to a combustion instability problem, more air was directed through the primary air ports by reducing the area of the dilution holes on one side of the reactor tube. This did not have a noticeable effect on the combustor instability problem, but it did slightly increase the pressure loss of the combustor and thus accounted for some of the scatter shown in figure 31.

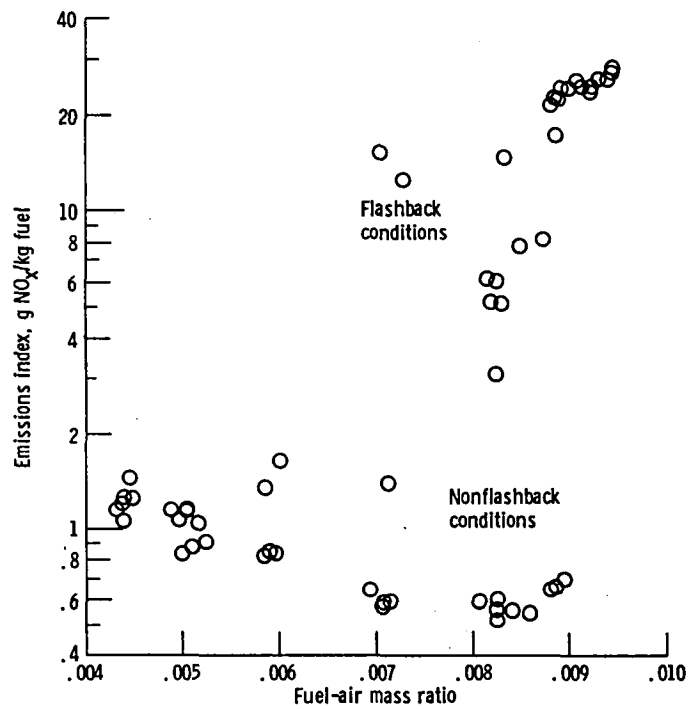
Figure 35. - Relationship between oxides-of-nitrogen emission index and fuel-air mass ratio. Low-pressure-side regenerator inlet temperature, T_8 , 748° C; high-pressure-side regenerator outlet temperature, T_4 , 715° C.

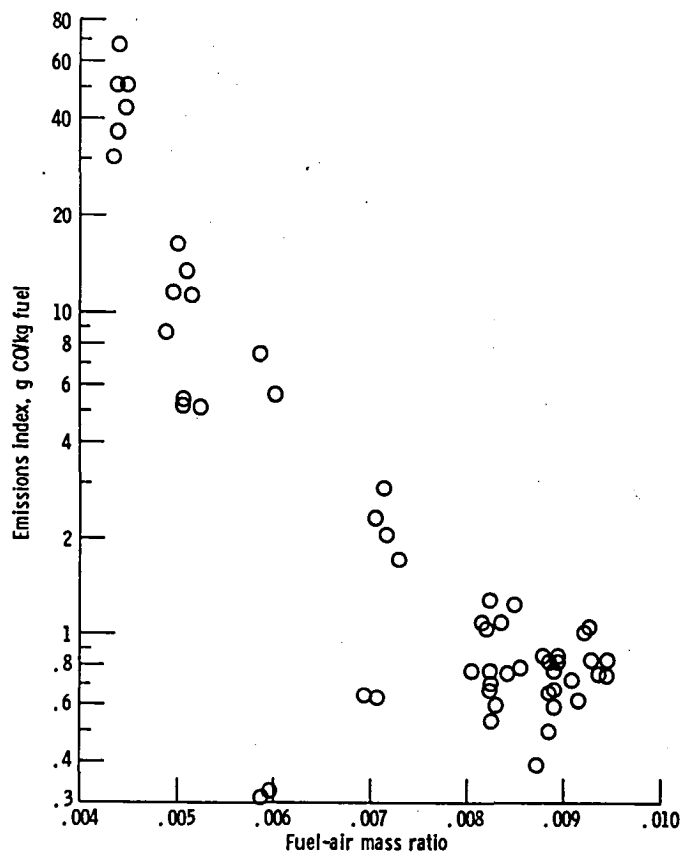
Figure 36. - Relationship between carbon monoxide emissions index and fuel-air mass ratio. Low-pressure-side regenerator inlet temperature, T_8 , 748° C; high-pressure-side regenerator outlet temperature, T_4 , 715° C.

Figures 36 and 37 show that CO and HC emissions are very high at idle conditions. High levels of HC and CO, which are products of incomplete combustion, are thought to be caused by the torch burning rich at idle. The torch is kept burning in order to relight the combustor after it goes out when fuel flow shuts off during deceleration. It is thought that the torch burns fuel rich and that, while the engine is near idle, the combustion of the torch fuel is incomplete.

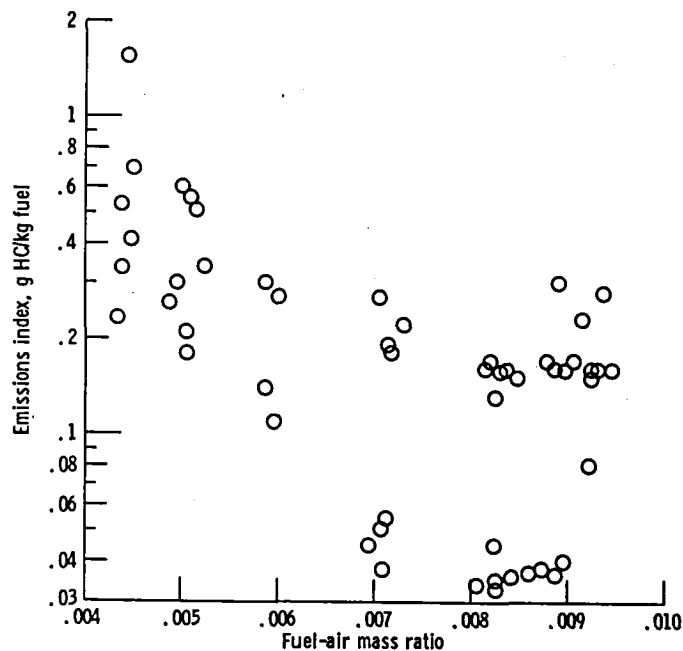
Figure 37. - Relationship between hydrocarbon emissions index and fuel-air ratio. Low-pressure-side regenerator inlet temperature, T_8 , 748° C; high-pressure-side regenerator outlet temperature, T_4 , 715° C.

If it is assumed that a vehicle with an improved Chrysler upgraded engine could get at least 20-mpg fuel economy, an emissions index less than about 2.8 over the driving cycle would result in meeting the vehicle emissions standards for HC or NO_x . Any CO emissions index below 24 would meet the emissions standards for CO. As shown in figure 35 the only time the NO_x emissions index was above 2.8 was then the combustor was in "flashback" condition. Figure 36 shows that under normal steady-state operating conditions the CO emissions index exceeds its allowable level only at idle. Figure 37 shows that HC does not exceed the allowable emissions level, even at idle.

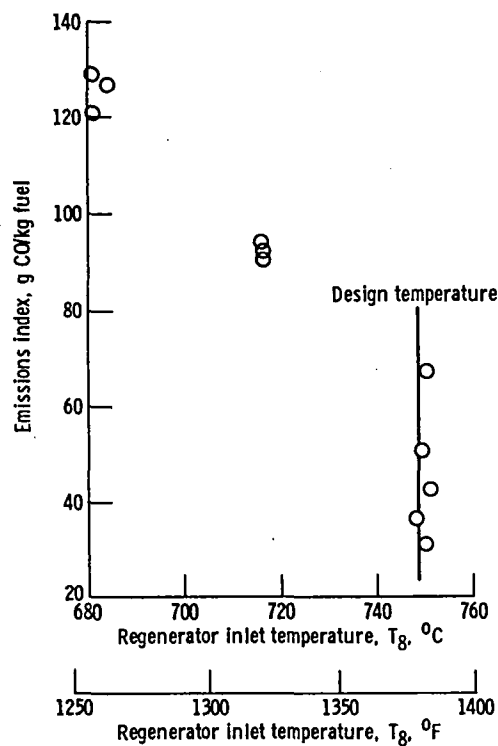
Figure 39. - Increase in carbon monoxide emissions for low-temperature idle. Gas generator speed, NGG, 50 percent of design. Design speed, 58 500 rpm.

However, at idle conditions both the CO and HC emissions are very sensitive to regenerator inlet temperature. Figures 39 and 40 show that the emissions levels climb dramatically with only a 70 K decrease in regenerator

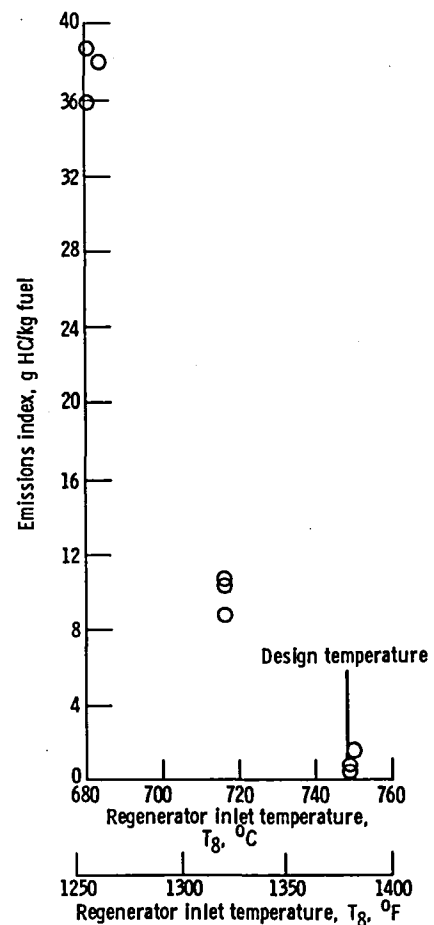
Figure 40. - Increase in hydrocarbon emissions for low-temperature idle. Gas generator speed, NGG, 50 percent of design. Design speed, 58 500 rpm.

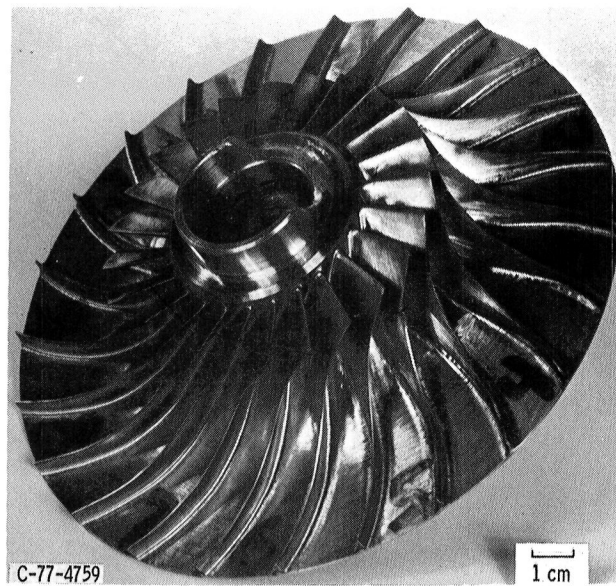
Figure 41. - Compressor rotor with inducer.

The compressor consists of variable inlet guide vanes, a 24-blade steel inducer, a 24-blade, 30°-backswept centrifugal rotor of cast aluminum, a 14-radial-vane diffuser, and 60 axial straightening vanes. Figure 41 shows the inducer and the compressor rotor. The rotor is 0.155 meter in diameter with a maximum operating speed of 58 500 rpm and a burst speed of 89 500 rpm. Compressed air is diffused into a three-chamber collector that is enclosed by the compressor cover. Two large chambers lead to the regenerator, and one smaller chamber sends cooling air first to the bulkhead located in the interstage area between the gas generator and power turbine sections and then to the regenerator inlet.

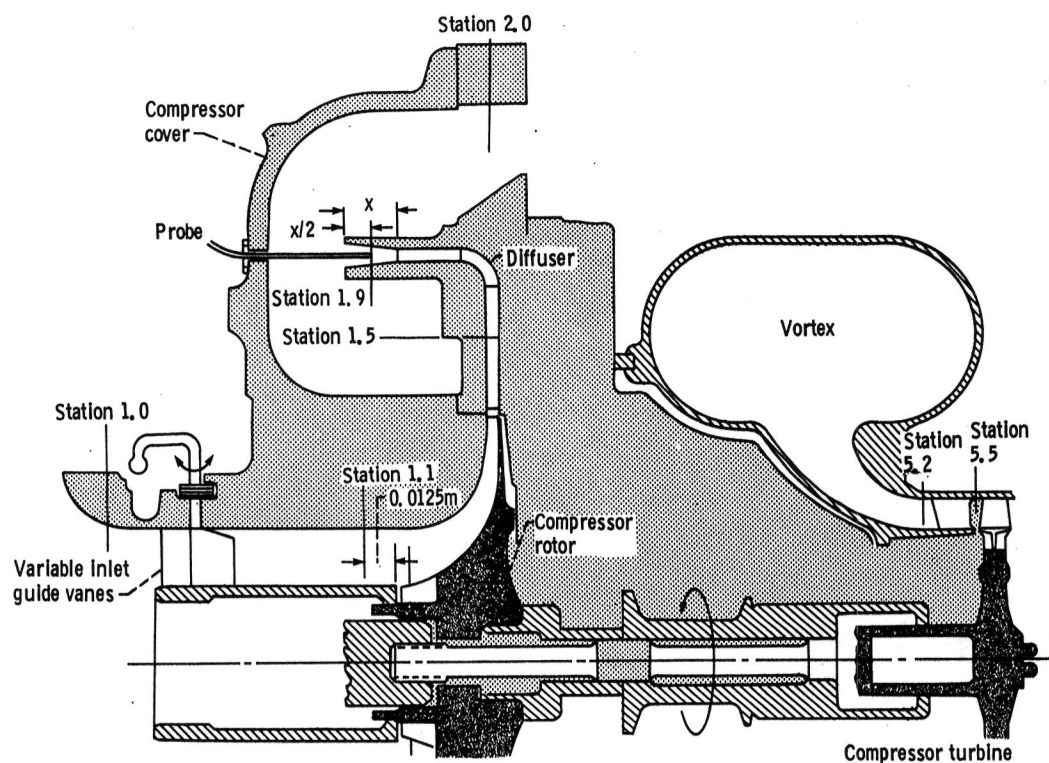
Figure 45. - Gas generator instrumentation station locations.

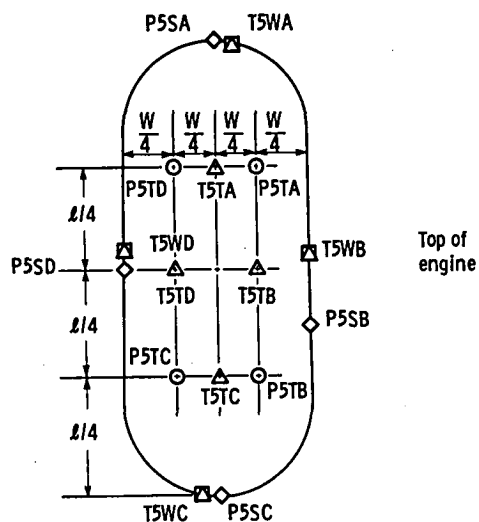
- ◇ Static pressure tap
- Total pressure probe
- △ Total temperature probe
- ▣ Wall temperature

Figure 53. - Station 5 - view into combustor exit.

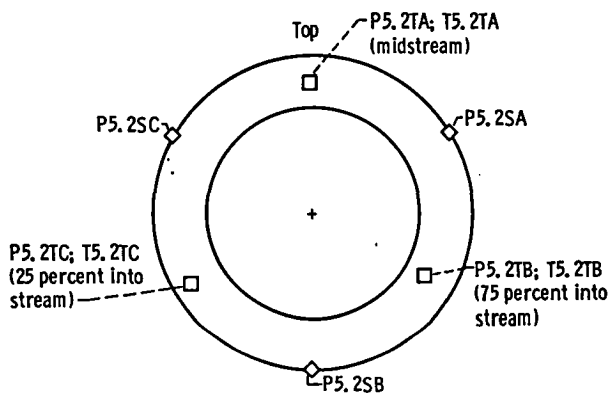
- ◇ Static pressure tap
- Kiel probe (total temperature and pressure)

Figure 54. - Station 5.2 - compressor turbine stator inlet.
